Case Study**Fill pack replacement**

Sydney Icon Gets a Cool(ing) Makeover

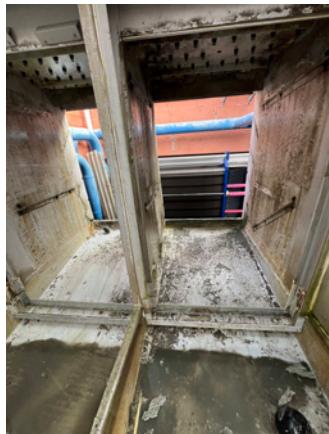
Work in progress showing empty cooling tower

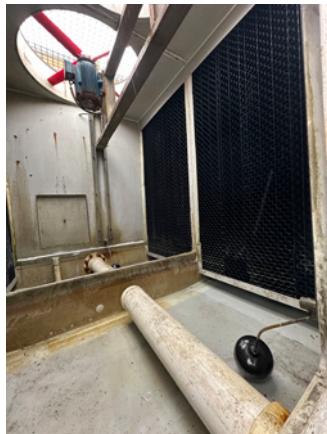
Work complete showing internal view

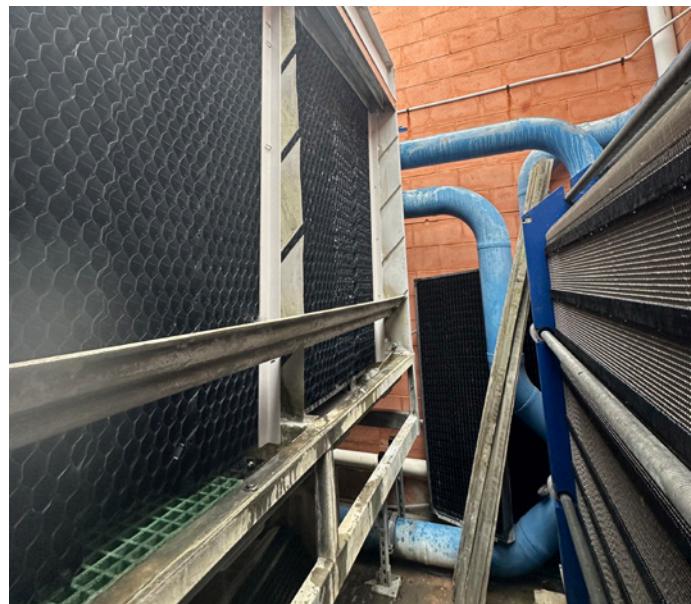
One of the initial challenges facing the HydroChem team performing the work was access. Space was very tight around the cooling tower and careful planning was necessary to safely remove and replace the fill pack.

Work complete showing limited access and XF75IL Crossflow blocks installed

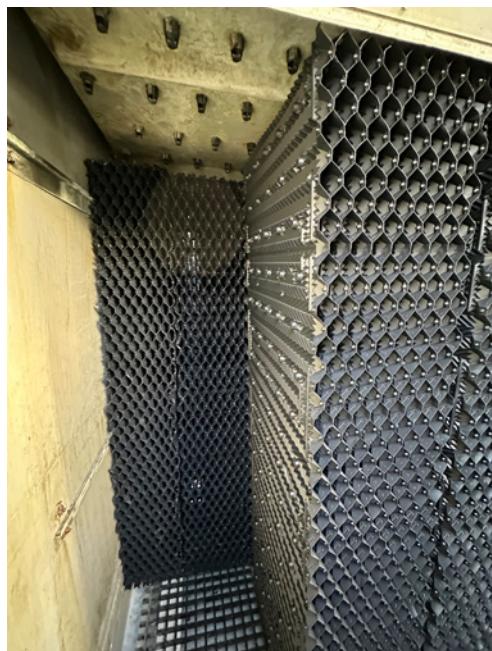
XF75 fill pack modular blocks during installation

HydroChem replaced the original sheet fill with more modern, modular block fill pack. This resulted in improved efficiency, durability, and makes future maintenance easier to undertake. The modular design also aided installation within the restricted access area in the vicinity of the cooling tower.

Sheet fill is known to stretch and flutter over time allowing air and water to bypass the media, reducing efficiency and potentially increasing the possibility of drift. Block fill eliminates these points of failure as the smaller modular blocks are rigidly adhered into solid, larger blocks and designed to have a supporting base. Block fill pack is much thicker than fill sheets – up to 85% – and provides enhanced longevity and UV resistance.

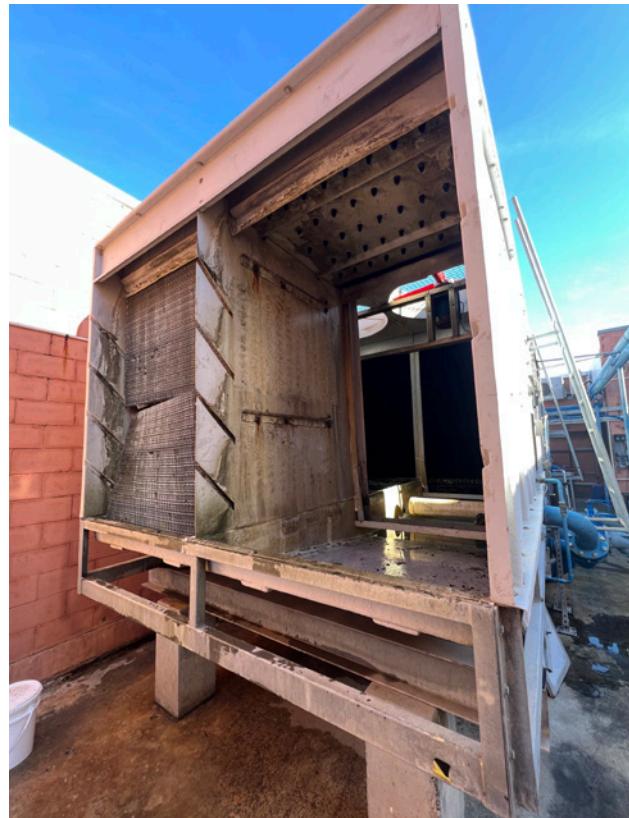
During the scoping of the project, the existing Temcel crossflow cooling tower was identified to be fitted with original sheet fill. This once commonplace technology is now outdated and no longer considered optimal for tower performance and maintenance.

Work in progress shows old crossflow sheet fill being stripped from the cooling tower

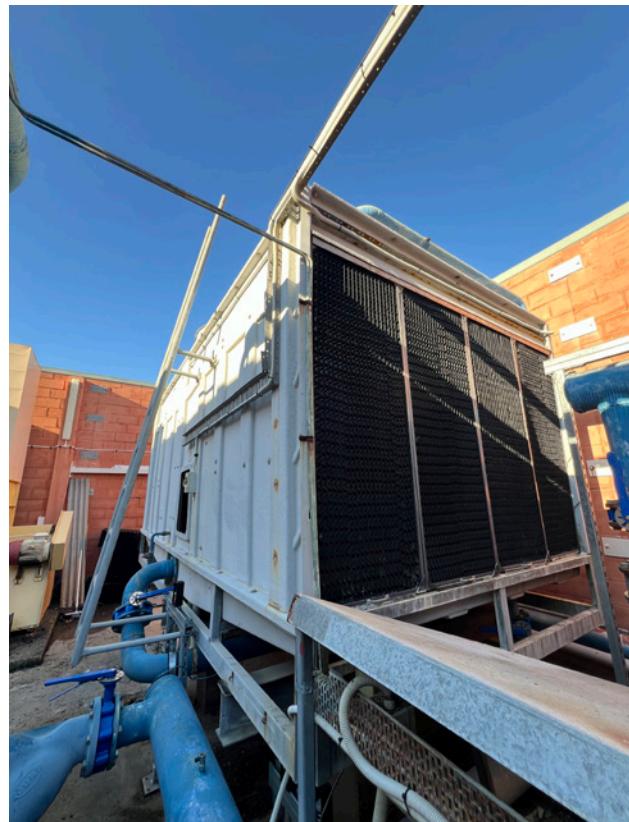
Cooling tower with old crossflow sheet fill prior to work commencing
