Data Centre Tower Clean Confirms Impressive Passivation Success

The background

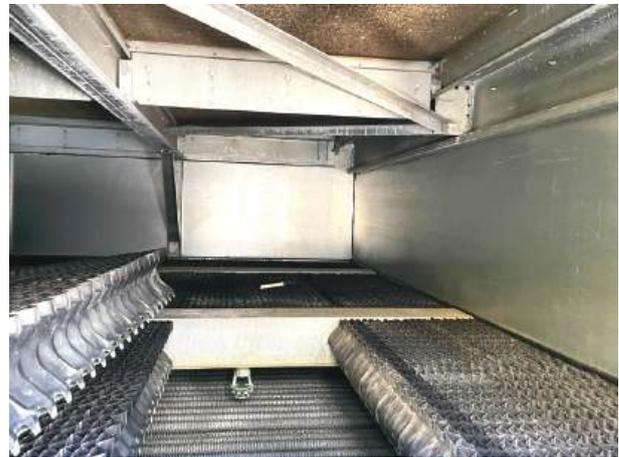
The cooling tower above the drift eliminators with a section removed reveals a spray arm that evenly distributes water to cool the galvanised steel heat exchanger tubes below.

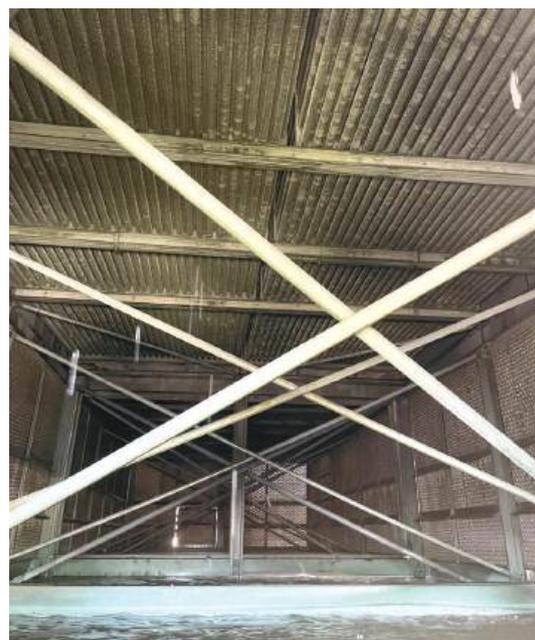
Upon inspection the cleaning team found the equipment was in exceptional condition despite five years of continuous operation. All surfaces remained well passivated, and showed no signs of white rust, iron oxide or hard water scale. The heat exchanger tubes were also in excellent condition with a passive surface and only a very light coating of dust and dirt.

Internal view from the basin of the passivated cooling towers shows the rows of galvanised steel heat exchanger tubes above.

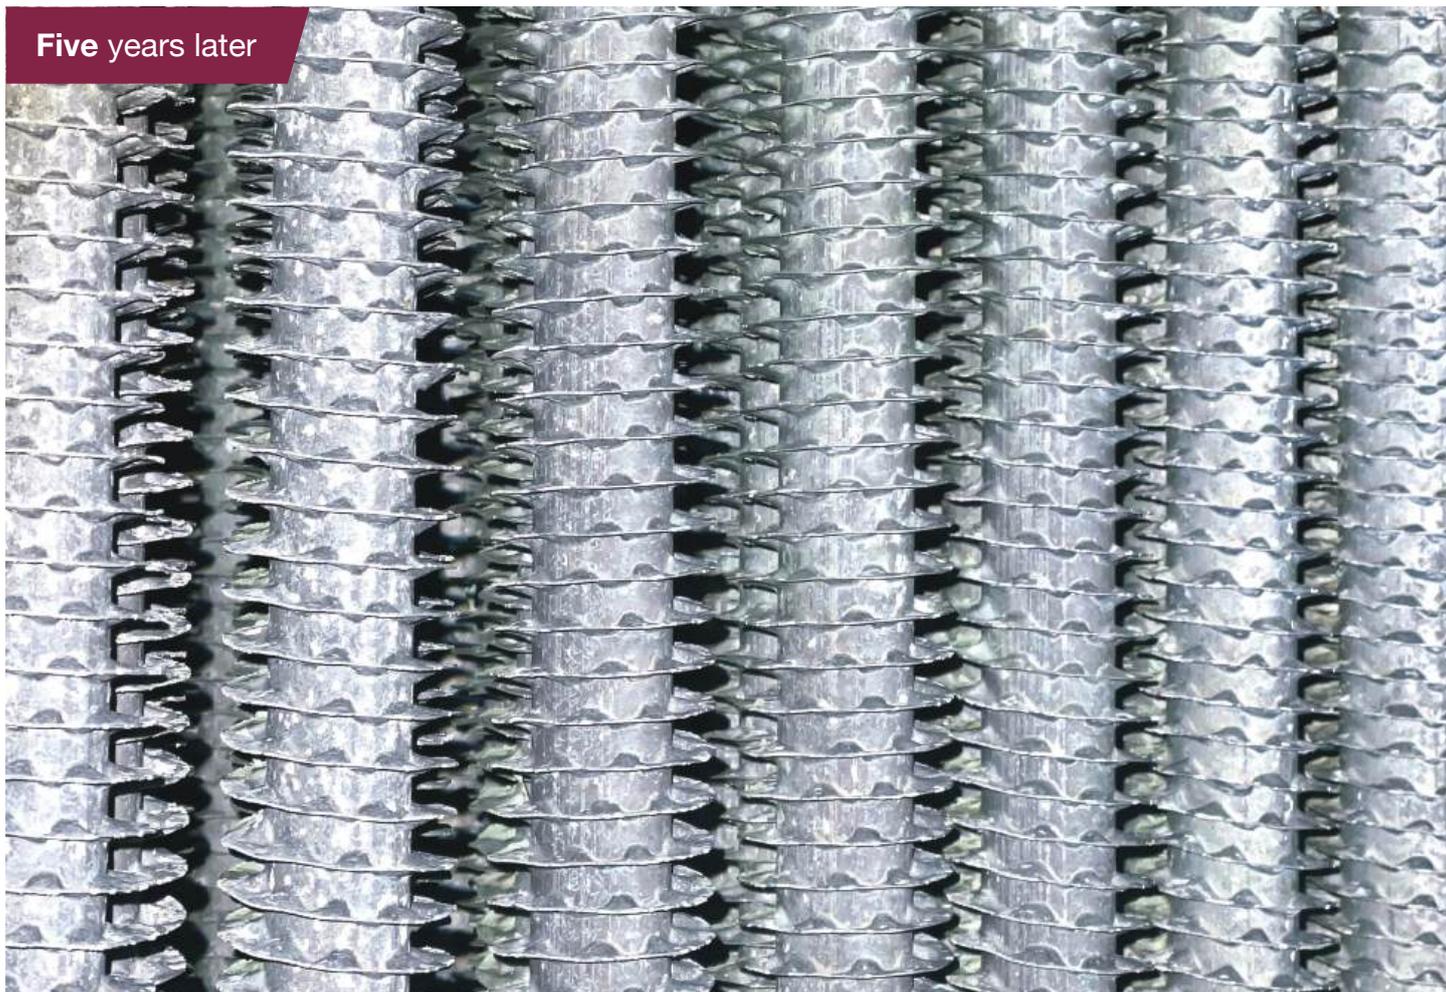
Five years later

The galvanised steel heat exchanger tubes show no degradation five years after passivation.
